CASE STUDY

Team : **MINA SERVICE**

Customer: **GRUPPO MARCEGAGLIA**

Project Details :

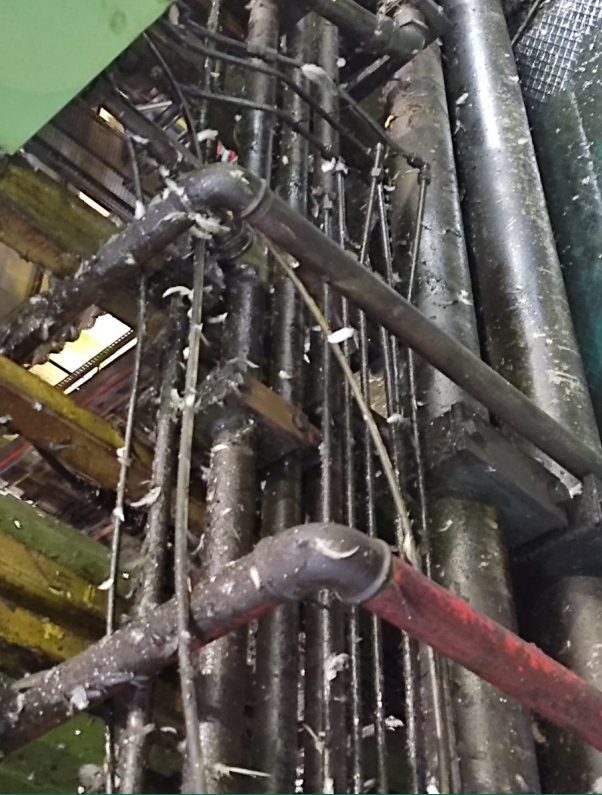
Poor overall condition of the tube

The condition of the tube was poor overall, it was covered with grease and dust which could increase external corrosion. There was leakage of hydraulic oil at the elbow joints creating a potential hazard for people and the environment. Furthermore, it was unable to provide the desired amount of efficient work needed to maintain the hydraulic system at prior levels.

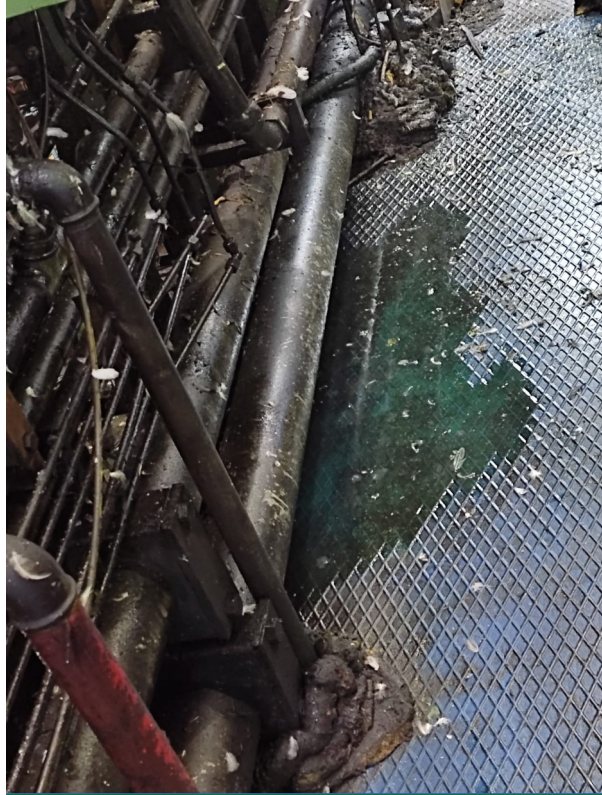
Leakage

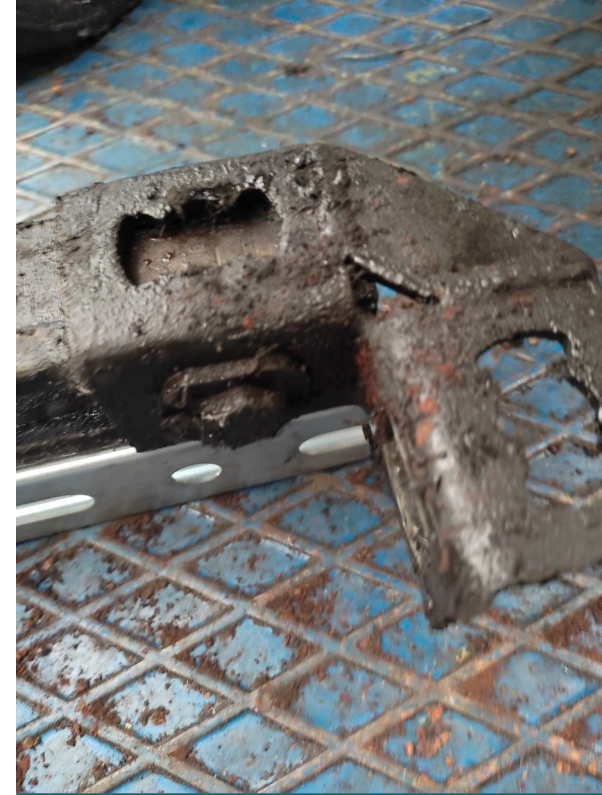
Lingering/unproperly supported

The frame was improperly supported, partially corroded, and loose at the ends, which eventually led to shaking. Therefore, the compromised support structure caused the tubes to bend, in certain cases. This eventually lead to the inefficiency of the whole system.

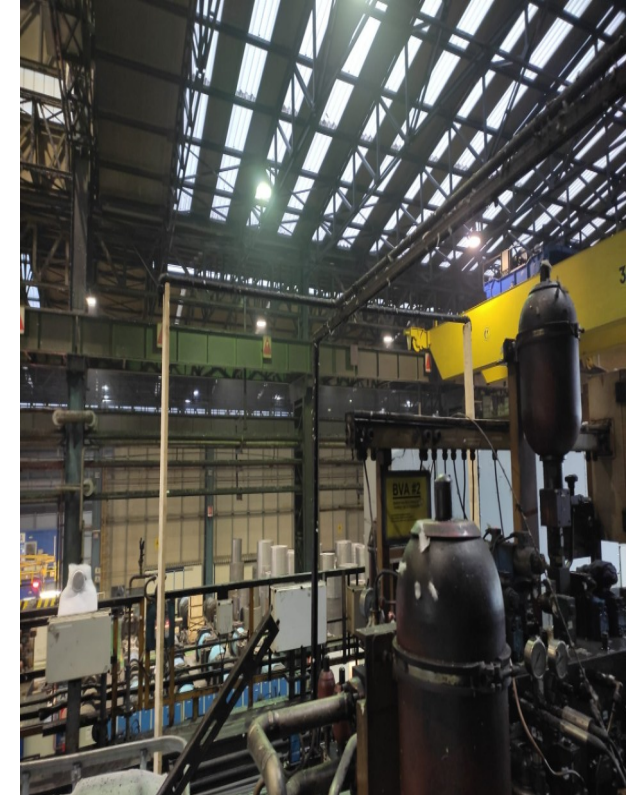
Partially corroded

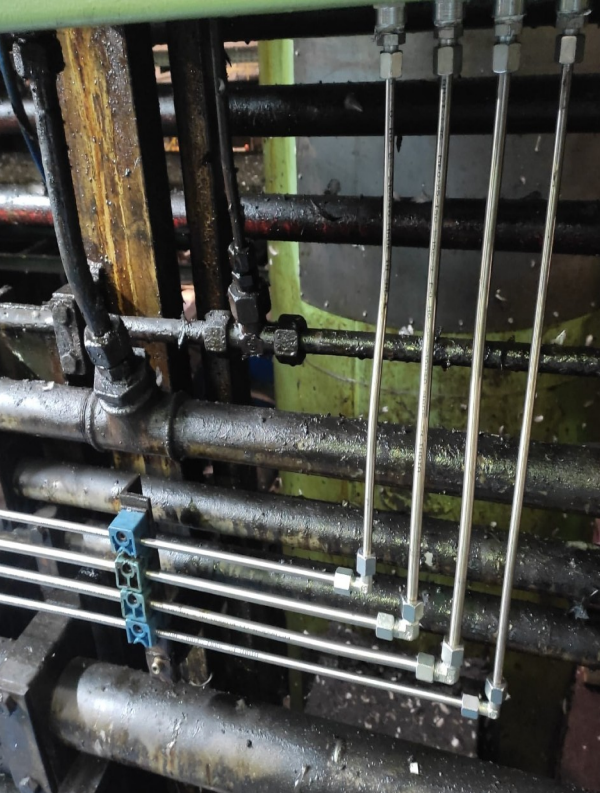
Tube is in mint condition

In order to revamp the system and ensure its functionality the leaks were eliminated, new tubing was installed and improvements were carried out on the support structure. Proper casing & elbows were provided to protect and reinforce the pipe from bending for any reason.

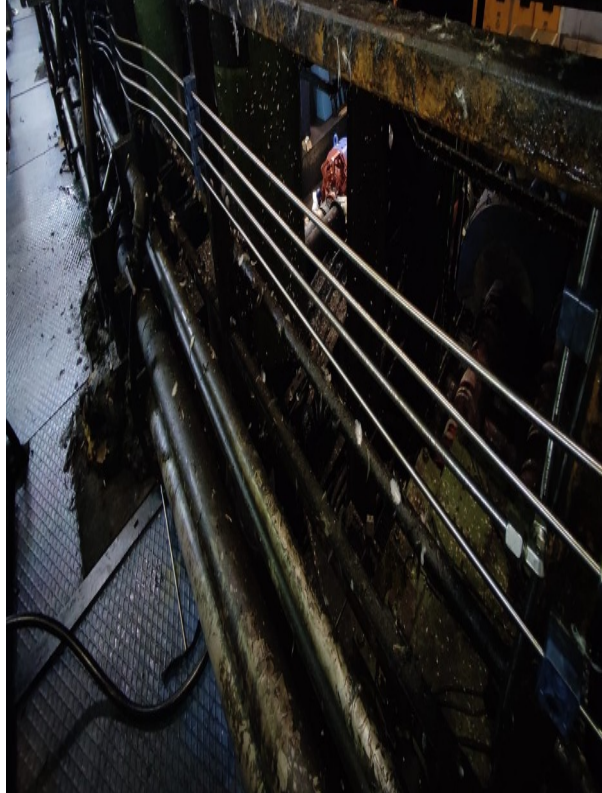
Leakage issue has been resolved

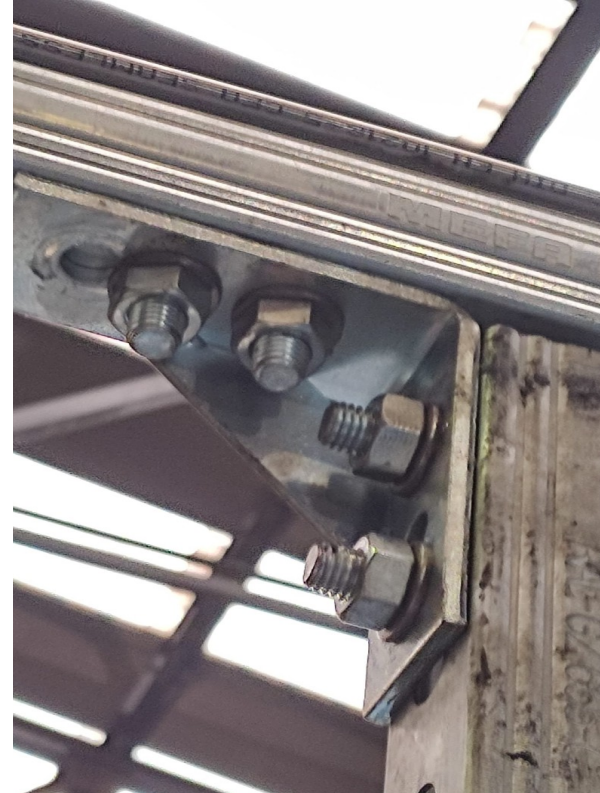
Strengthened supporting structure

Fixing elements with a different shape and design were installed to provide extra supports and avoid vibrations, as they ensure the stability and rigidity of the structure.

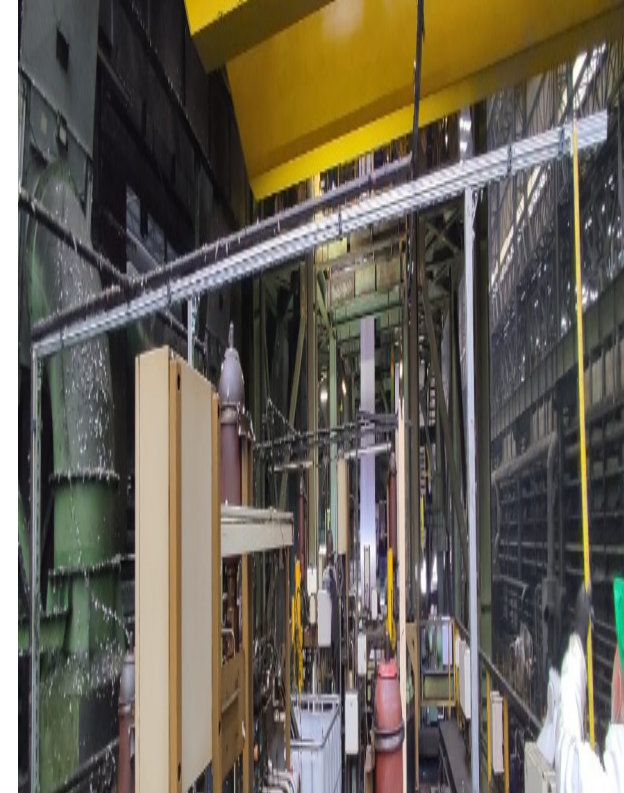
Properly supported frame structure

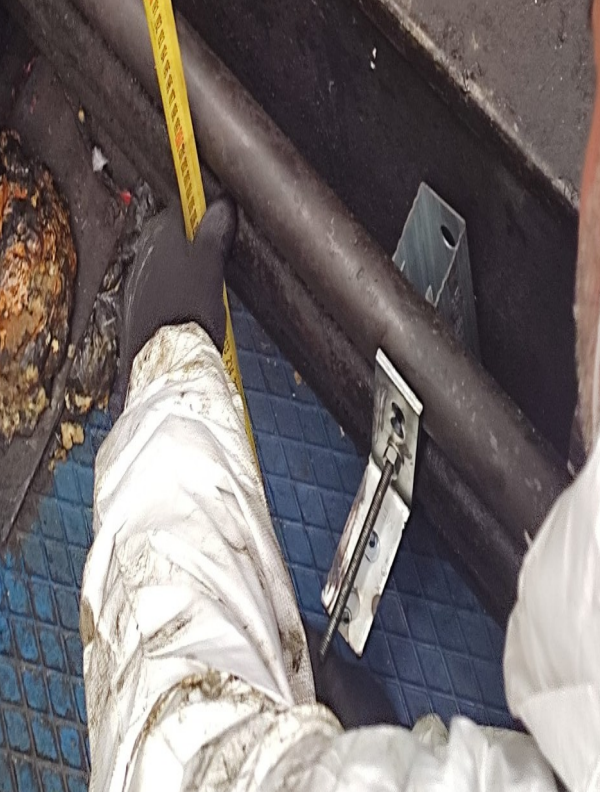
The adjustable elbow was placed as per the safety norms

Extra base support was provided to the 8mm and 10mm tubes to pass through the base. The elbow visible on the left side of the picture could not be attached to the side rail as it contained wirings. We resolved this issue by attaching it to the previously mounted pipeline in order to maintain safety and structural integrity.

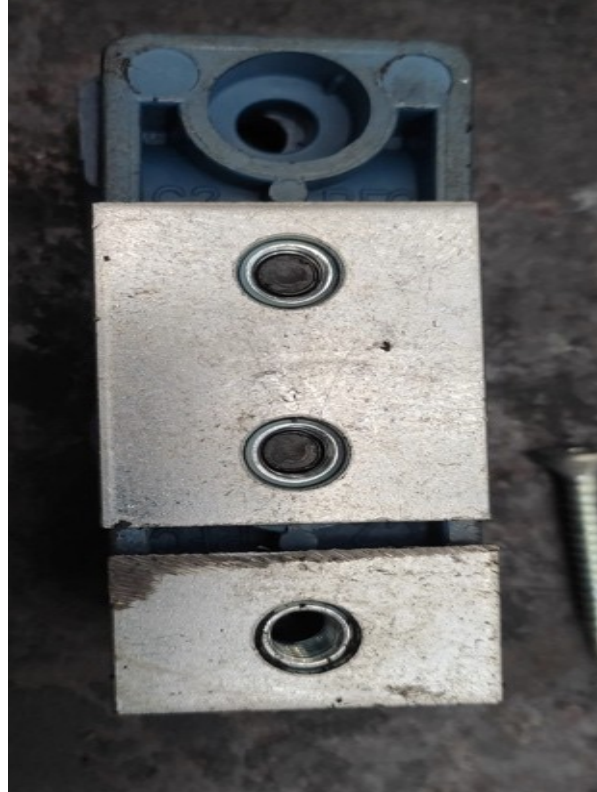
Casing re-considered

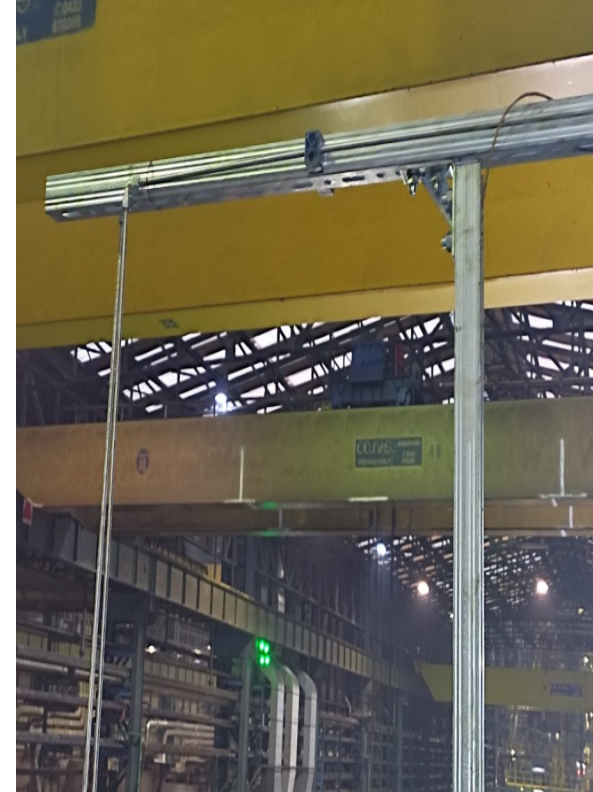
Extra frame rail as per HSE recommendation

The metal rails were extended as per HSE recommendation. The extra rails support the tube and provide extra space for the workers in case of an emergency evacuation.

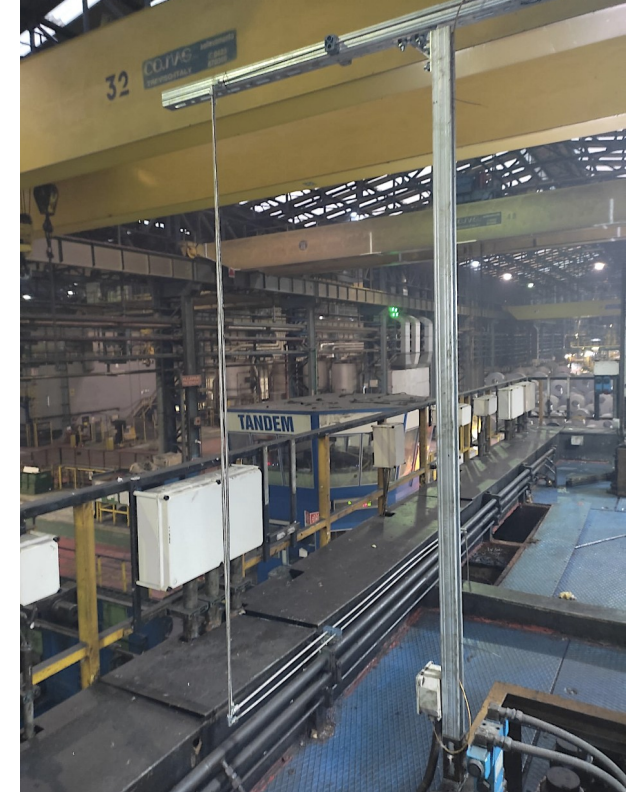
Extra frame rail as per HSE recommendation
